NRL/MR/6180--06-8983

# Final Report on Fire Performance of Shipboard Electronic Space Materials

*Navy Technology Center for Safety and Survivability  
Chemistry Division*

September 15, 2006

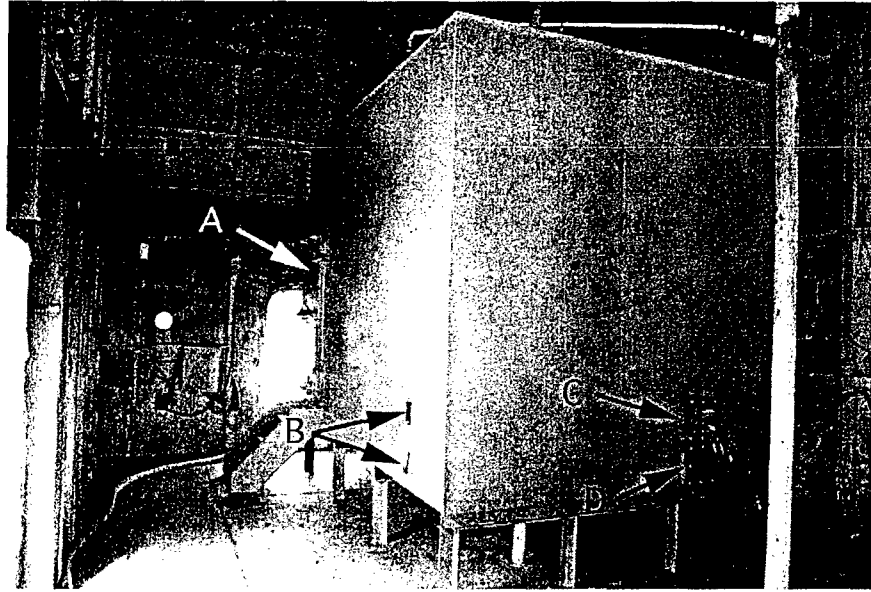
Figure 1. Exterior View of Electronic Space Mockup

A mockup of a generic, shipboard electronic space, shown in Figure 1, was constructed at the NRL Chesapeake Bay Detachment (CBD). The mockup design was based on the configuration used in the Combat Systems Equipment Rooms (CSERs), Tomahawk Equipment Room and Combat Information Center (CIC) spaces on the *USS Arleigh Burke* (DDG-51) class ships. This class was chosen because it is representative of current US Navy surface ship electronic spaces. It is expected that lessons learned from tests of this configuration will be applicable to future combatant designs, including the DD(X) destroyer and the Littoral Combat Ship (LCS).

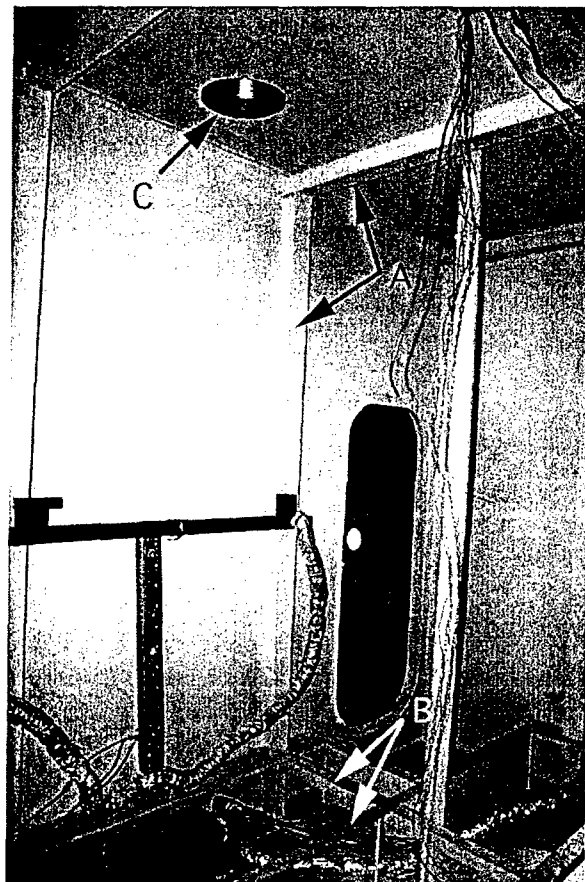
Figure 2A. Interior View of Electronic Space Mockup

This photograph shows the interior of the electronic space mockup, as viewed from the forward, port corner looking toward the watertight door. The vertical and horizontal stiffeners (A) are 10 cm (4 in.) "T" beams; the grids near the bottom of the picture (B) support the false deck panels (not installed). The exhaust ventilation is the circular port visible at the the top (C).

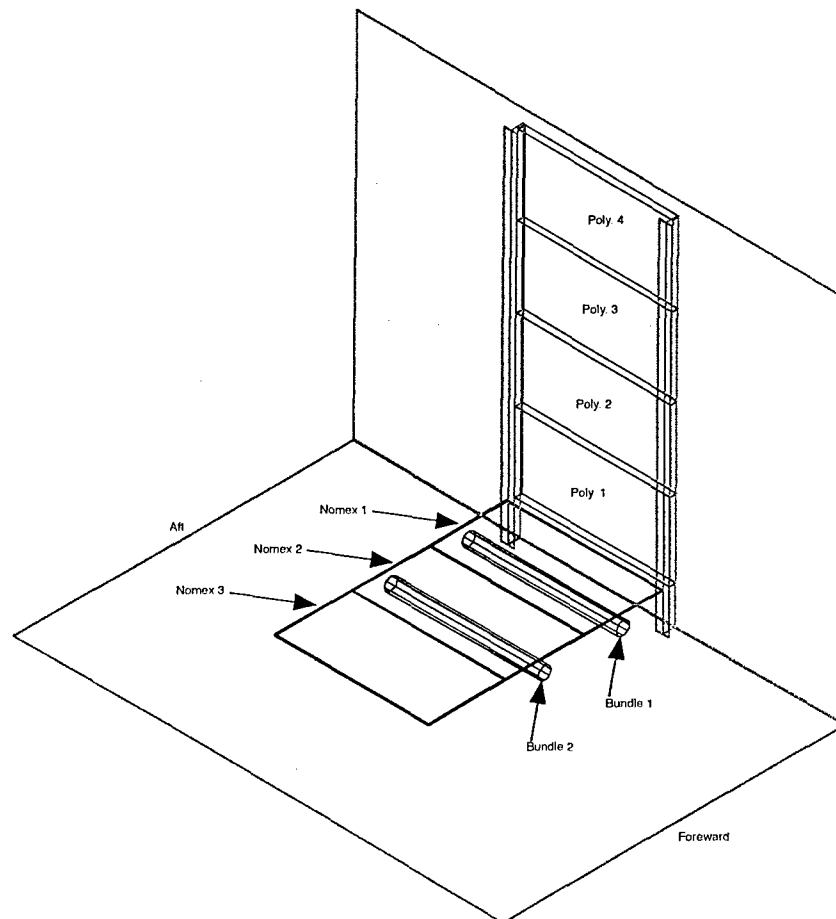
Figure 3. Layout of Fuel Load

the fuel. Each of fuel configurations is discussed in more detail below. The relative locations of cable bundles, Nomex panels and polyimide insulation panels is illustrated in Figure 3, where each cable bundle, Nomex deck panel and polyimide insulation panel is numbered for reference.

The insulation panels (Figure 11) were installed in the frame gap immediately adjacent to the Nomex 1 deck panel (see Figure 3). The lowest insulation panel, Poly. 1, was at the level of the false deck; the other three were numbered in ascending order above that.

For each test, pre-weighed fuel items were installed at the locations shown in Figure 3. Various combinations of cables, Nomex deck panels and polyimide insulation panels were used, depending on the test requirements, as shown in Table 4. New fuel items were used, except in cases where the item in question had not been damaged during the previous test. These cases are discussed below.

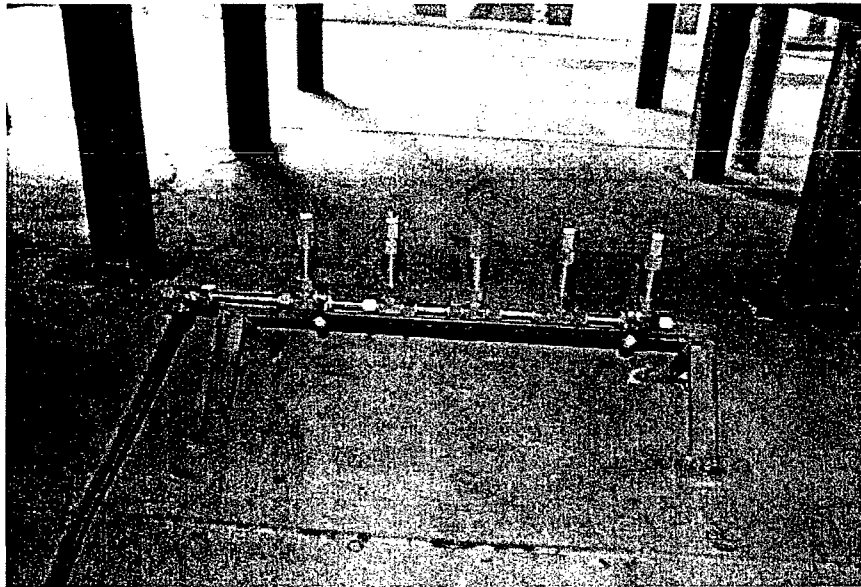
Figure 4. Spray Fire Nozzle Array

The spray nozzle array, shown in Figure 4, consisted of five nozzle stations and was located in the crawl space under the test compartment, directly below the Bundle 1 location. Nozzle stations were closed off with pipe plugs when not in use.

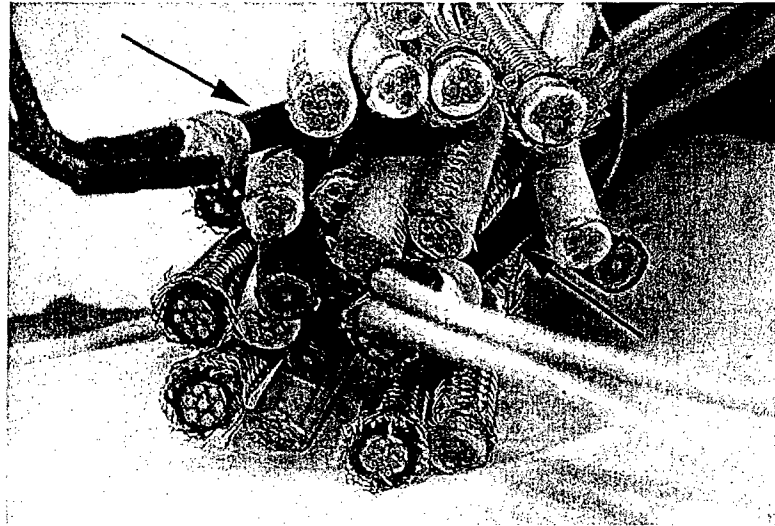
Figure 6. Cable Bundle

axially into the first bundle, as illustrated in Figure 6. A typical bundle, installed on a cable tray, is shown in Figure 7. The power cables for the tubular heaters were wrapped in Fiberfax and aluminum foil insulation and extended from the aft end of the bundle.

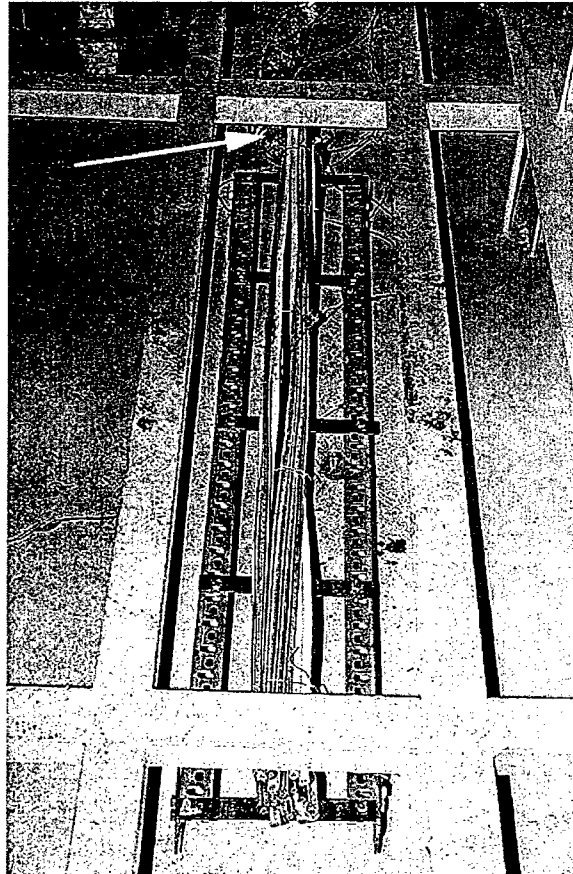
Figure 7. Cable Tray

A typical cable bundle, consisting of five lengths of each of five cable types, is shown installed on a cable tray. The arrow points to the insulated power cables for the tubular heaters.

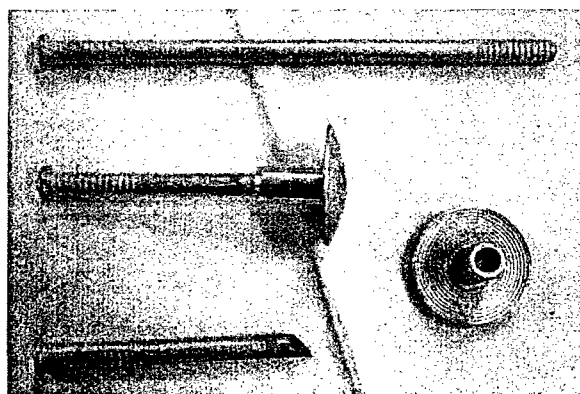
Figure 10. Insulation Installation Studs and Caps

These studs (Figure 10) look somewhat like blunt nails, the heads of which are welded to the bulkhead in a square pattern, about 30.5 cm (12 in.) on centers. As the name suggests, the caps resemble mushrooms and have hollow stems that are hammered onto the studs. Approximately one centimeter (0.5 in.) of the protruding end of the studs has circumferential grooves to provide a tight friction fit with the caps. These grooves make it difficult to remove the caps without damaging the studs.

The standard Navy studs (top) were modified by cutting off the grooved section to permit easy removal of the mushroom caps (right) for replacement of the insulation panels. A modified stud is shown at the bottom and a modified stud with the cap installed is in the middle.

Normally, the length of the stud is chosen to match the thickness of the insulation. However, due to the necessity for easy replacement of damaged panels, we used 10 cm (4 in.) studs and cut off the grooved end at an angle of approximately 45°. Without the grooves, caps and insulation panels were easily removed; the bevel cut provided a sharp point, which made it easier to punch through the insulation panels during installation.

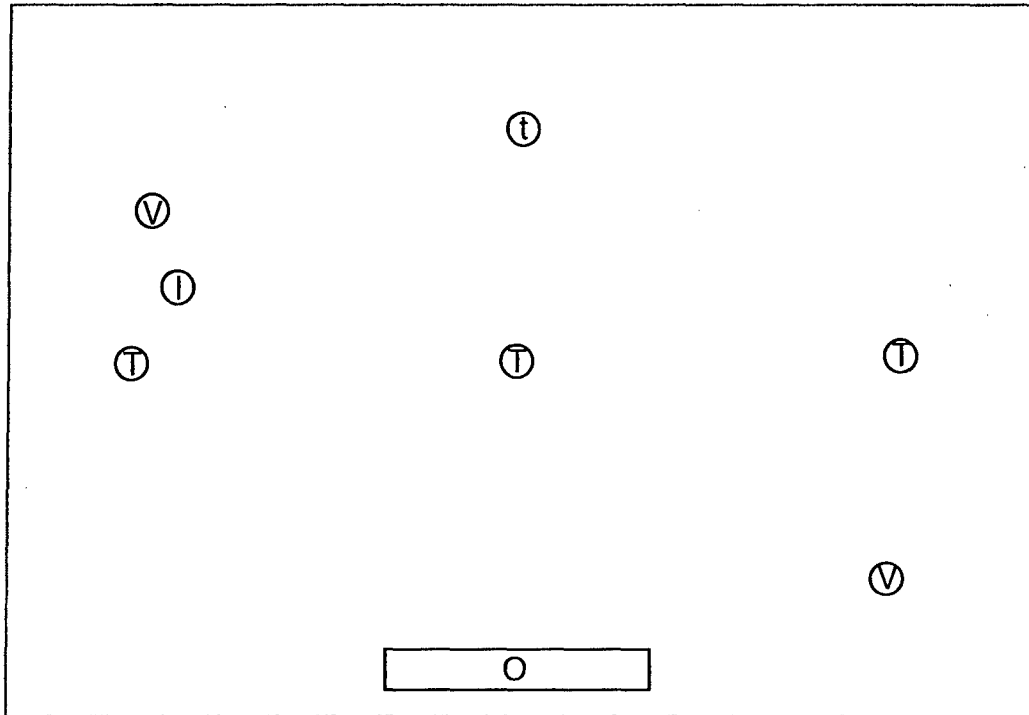
Figure 12. Plan View of Instrument Positions

Test instrumentation locations are shown in Figure 12; additional details are given in Table 3. Note that instruments located at elevations greater than 31 cm (12 in.) are above the false deck while those at lower elevations are below the false deck. Services (power, data connections and cooling, for example) for the below-deck instruments were provided via the MCT near the aft, starboard corner of the test compartment while those for the above-deck instruments were provided by the forward, port MCT.

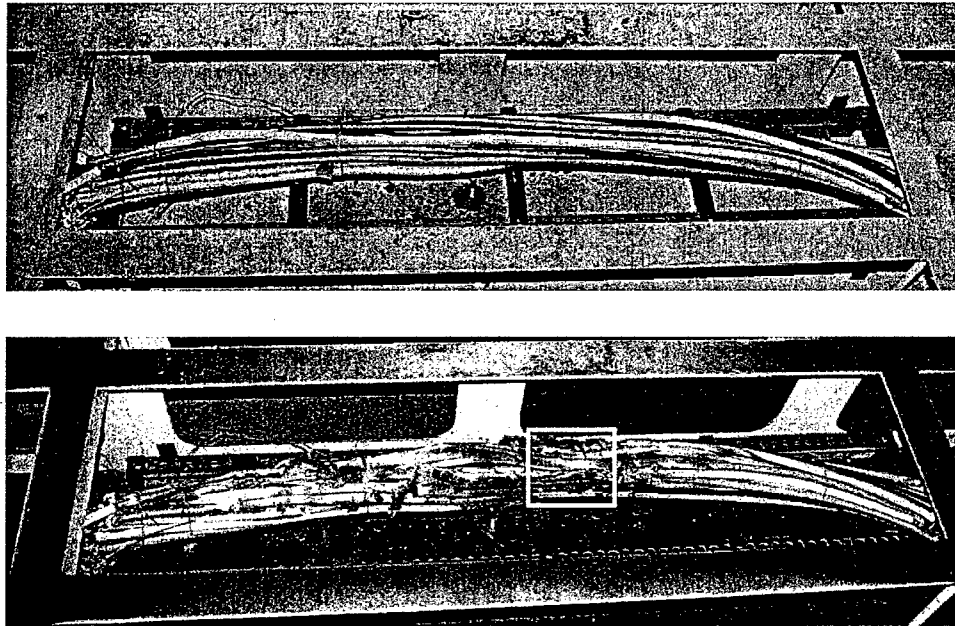
Figure 13. Pre- and Post-Test Views of Bundle 1 (Cable 1 Test)

Photographs of Bundle 1 before (upper) and after (lower) the Cable 1 test. The area inside the white rectangle in the lower photo is enlarged in the next figure.

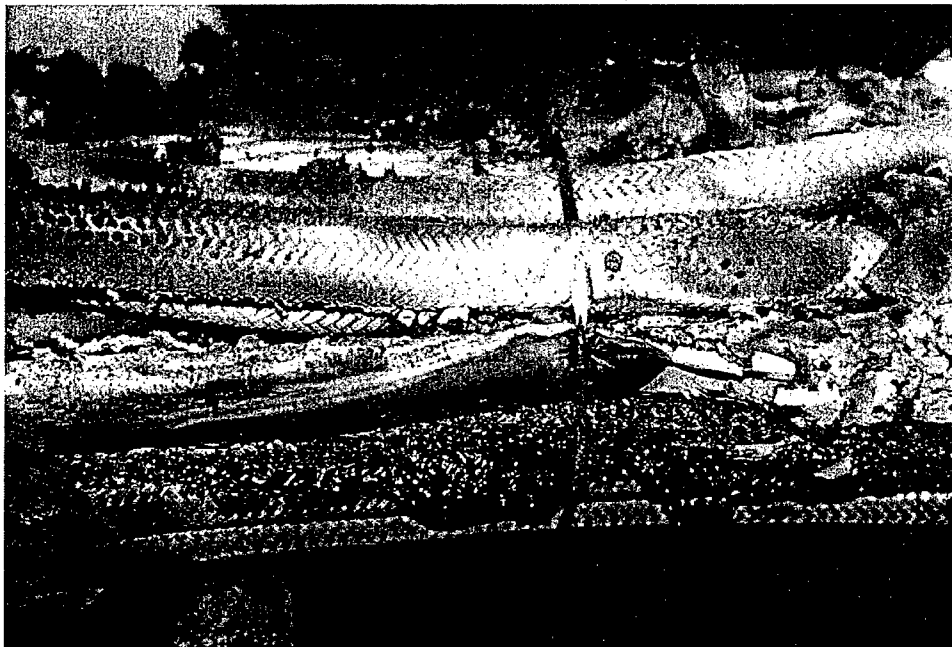
Figure 14. Enlargement of Bundle 1 (Cable 1 Test)

This enlargement of one of the most severely damaged portions of Bundle 1 after the Cable 1 test.

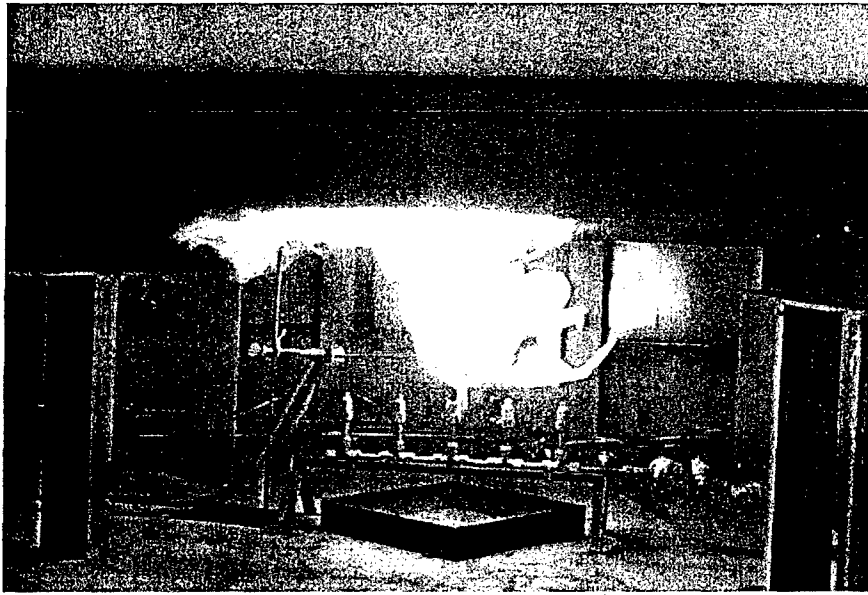
Figure 15. Single Nozzle Spray Fire (Cable 2 Test)

A single spray nozzle, producing an fire of approximately 226 kW, was the ignition source for the Cable 2 test.

The second cable test, Cable 2, was similar to the first except that the ignition source was a single nozzle (approximately 226 kW), as seen in Figure 15. Figure 16 shows that the paint was burned off of the deck above the nozzle but the cables, which were only 15 cm (6 in.) above the deck, never ignited and, in fact, suffered no apparent damage other than slight discoloration from smoke.

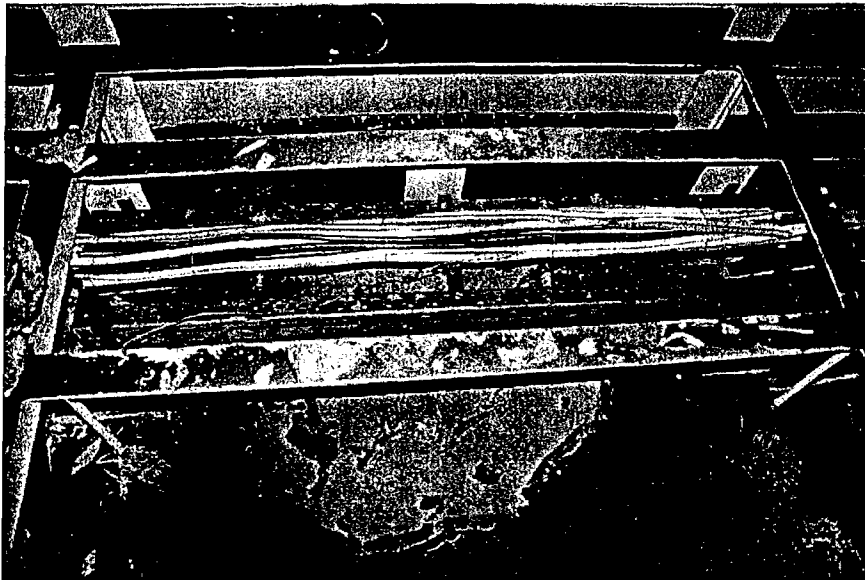
Figure 16. Results of Single Nozzle Spray Fire (Cable 2 Test)

The 226 kW spray fire burned the paint off the deck but did no noticeable damage to Bundle 1, which was only 15 cm (6 in.) above the deck.

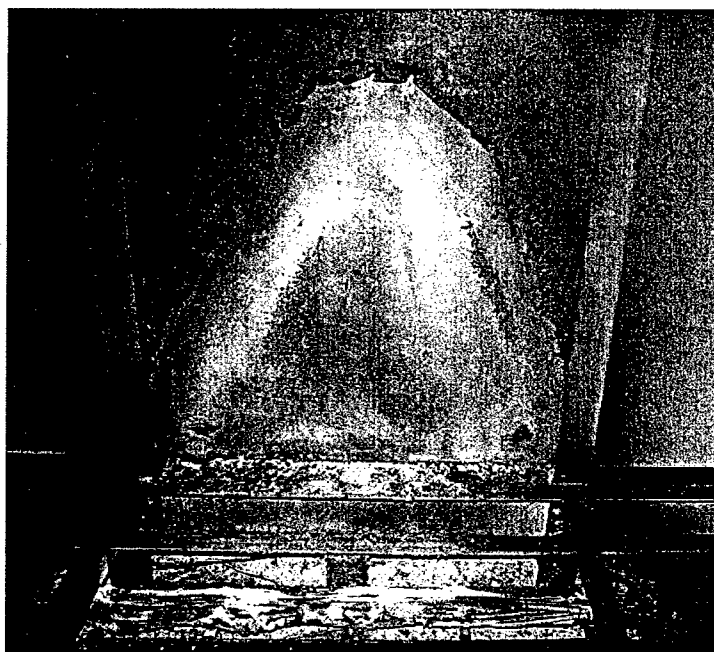
Figure 18. Results of Five-Nozzle Spray Fire (Cable 3 Test)

The 1.13 MW spray fire destroyed most of the cables in Bundle 1 and burned the paint off of a large section of the starboard bulkhead.

The Cable 3 test was a repeat of Cable 2, except that the ignition source consisted of a five-nozzle array (about 1.13 MW), as illustrated in Figure 17. The same cable bundle, which suffered no damage in the previous test, was recycled for this test. In this test, the cables did ignite and the bundle was heavily damaged (see Figure 18). In addition, the flames rose up the exterior of the starboard bulkhead, burning the paint off and damaging some of the instrumentation. As a result of this damage, the remaining spray fire tests were restricted to two nozzles.

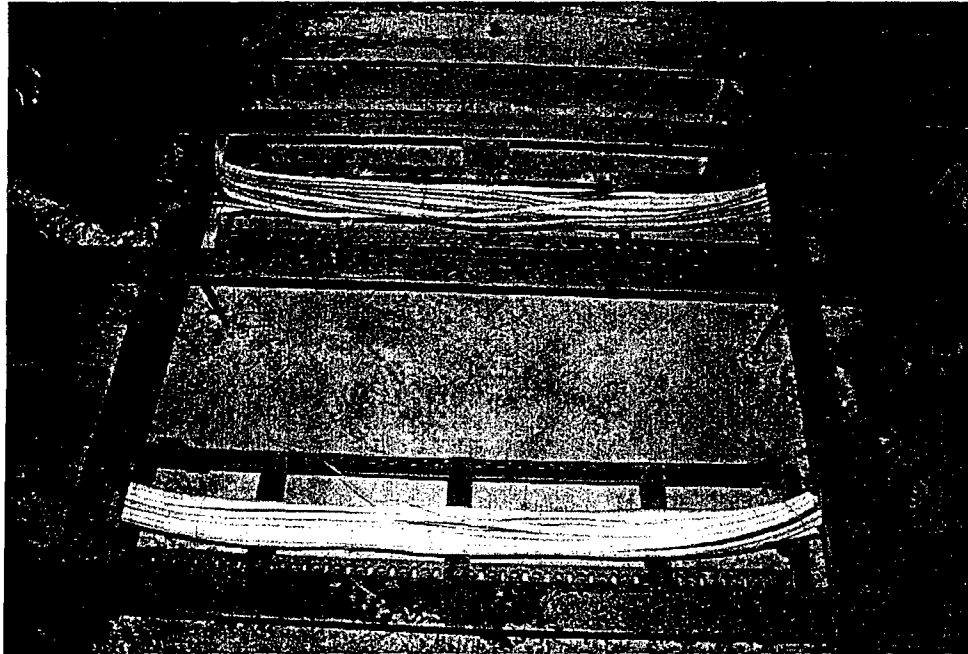
Figure 19. Two-Bundle Cable Placement (Deck 1 Test)

In addition to the standard Cable 1 placement, at the top of the picture, a second bundle (Bundle 2) was added, starting with this test. Only Bundle 1 had electric heaters installed as ignition sources. Note the igniter power cables, covered with aluminum foil for insulation, in the upper left.

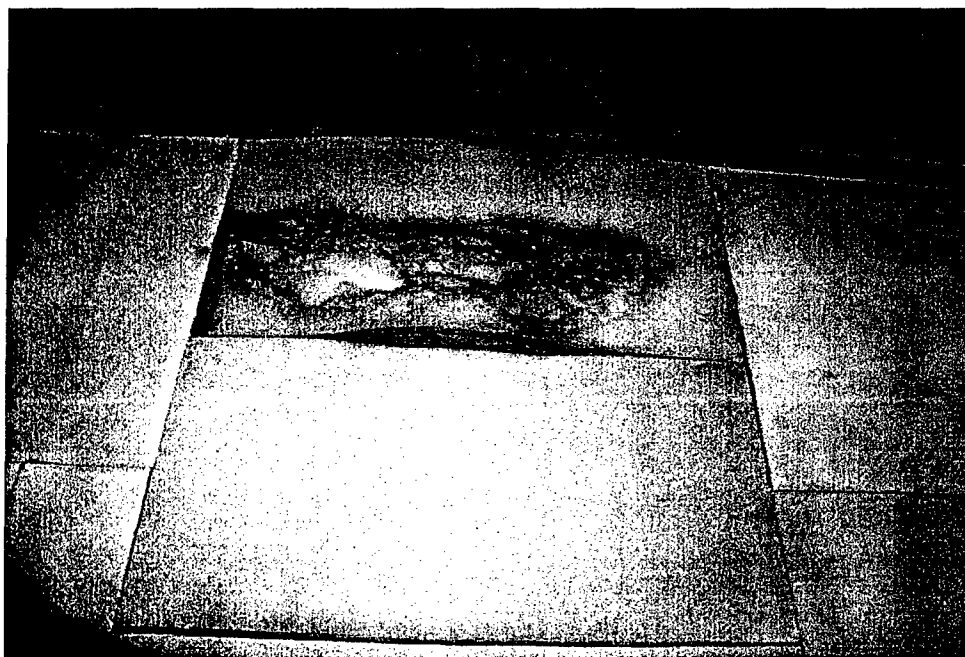
Figure 21. Post-Test Damage to Nomex Panels (Deck 1 Test)

After the test, the Nomex 1 panel was found to have been blistered and discolored on the top and Nomex 2 was slightly damaged. The Nomex 3 panel was covered in soot, but undamaged.

At the end of the test, we found that panel Nomex 1, directly above Bundle 1, was blistered and warped, Nomex 2 was slightly burned along the edge adjoining Nomex 1 and third panel (Nomex 3) was heavily sooted but not damaged (see Figure 21). Upon lifting the two damaged panels (Figure 22), large flakes of material were seen to be peeling off the bottom of Nomex 1 and additional material was found on the cables and deck below. The large blister seen on the top surface was due to delamination of the upper GRP layer from the Nomex core. The fire destroyed Bundle 1, as shown in Figure 22, but Bundle 2 was intact.

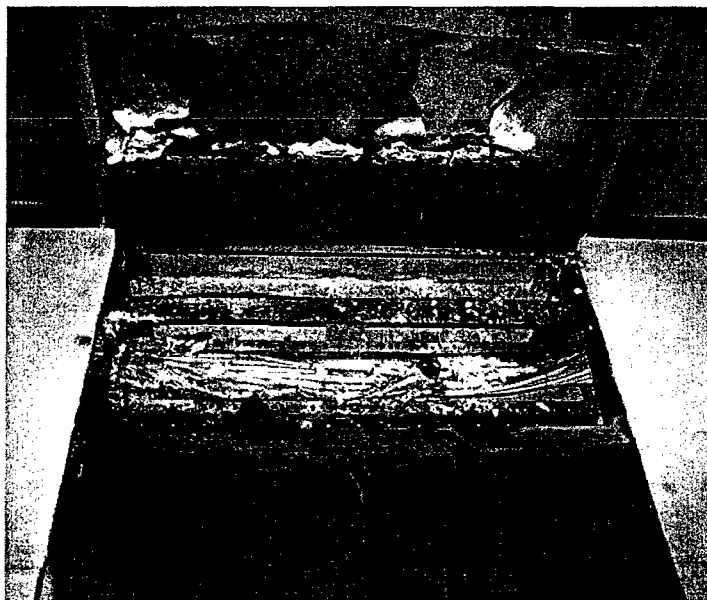
Figure 22. Post-Test Damage to Nomex 1 and Cable 1 (Deck 1 Test)

Nomex 1 has been lifted, and Nomex 2 turned upside down, to show the damage to the bottom of each panel. Note the warping along the upper edge of Nomex 1 and the large pieces of material that have peeled off from the bottom surface. Nomex 2 is scorched on one edge but is otherwise intact and Bundle 1 was destroyed.

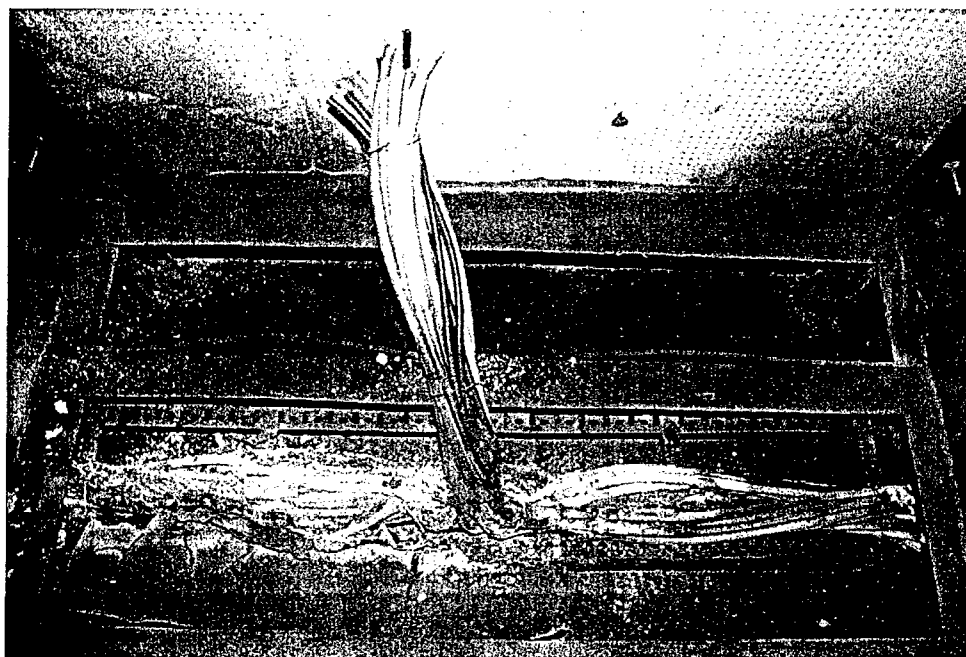
Figure 23. Special "T" Cable Bundle (Insulation 2 Test)

The results of this test are shown in Figure 23. Note that the below deck portion of the "T" bundle was burned out but the part that was above the false deck was relatively undamaged. Also, the Poly 1 panel was only slightly scorched at the lower corners. Figure 24 shows the Nomex 1 panel, removed from the test compartment after the test. The hole for the vertical branch of the "T" bundle is near the center of the panel.

The goal of this was to determine whether cables extending through holes in the false deck could act as wicks that might expedite ignition of nearby insulation panels. This construction mimics actual shipboard practice, where cables penetrate the false deck to reach connectors located on the rear of the electronic consoles.

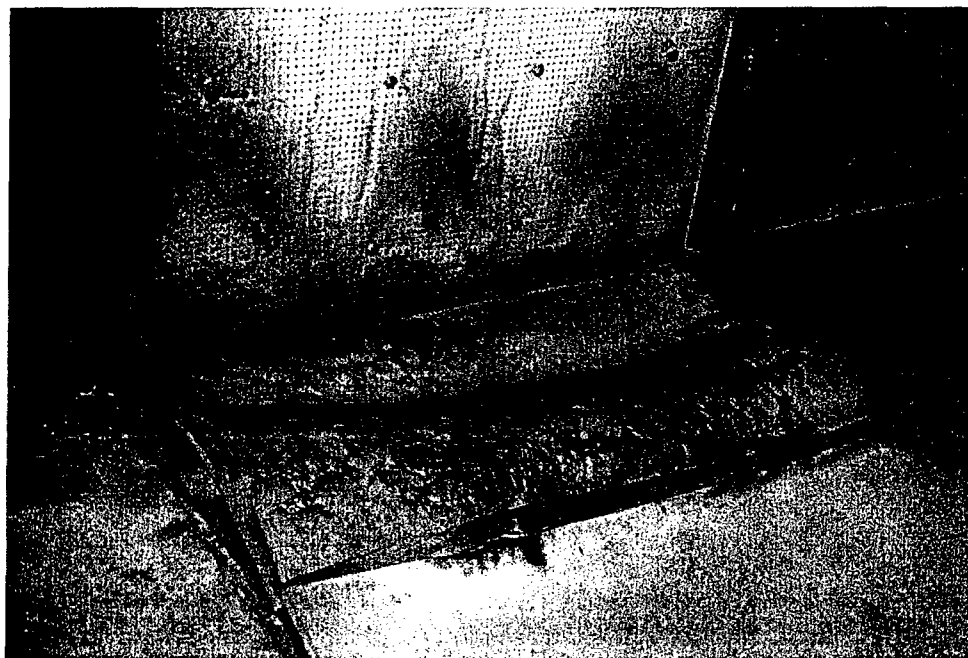
Figure 25. Post-Test Damage to Nomex 1, Nomex 2 and Poly 1 (Insulation 3 Test)

Nomex 1 has been reduced to a brittle shell (note the layers of GRP facing and the Nomex core visible on the left edge). Nomex 2 was damaged where it adjoined Nomex 1 and was severely warped. The Poly 1 insulation panel was scarcely damaged.

As seen in Figure 25, both the top and bottom GRP facings delaminated from the Nomex honeycomb core of the Nomex 1 panel, which was located directly above both Cable 1 and the spray fire. The Nomex 2 panel was severely warped and burned along the starboard edge, where it abutted Nomex 1. In Figure 26, the deck panels have been removed to show Cable 1. Note the many pieces of GRP that peeled off of the Nomex 1 panel. A close-up of a portion of the Cable 1 bundle is shown in Figure 27, where the outer electrical insulation has been completely burned away in places and has split open in other places.

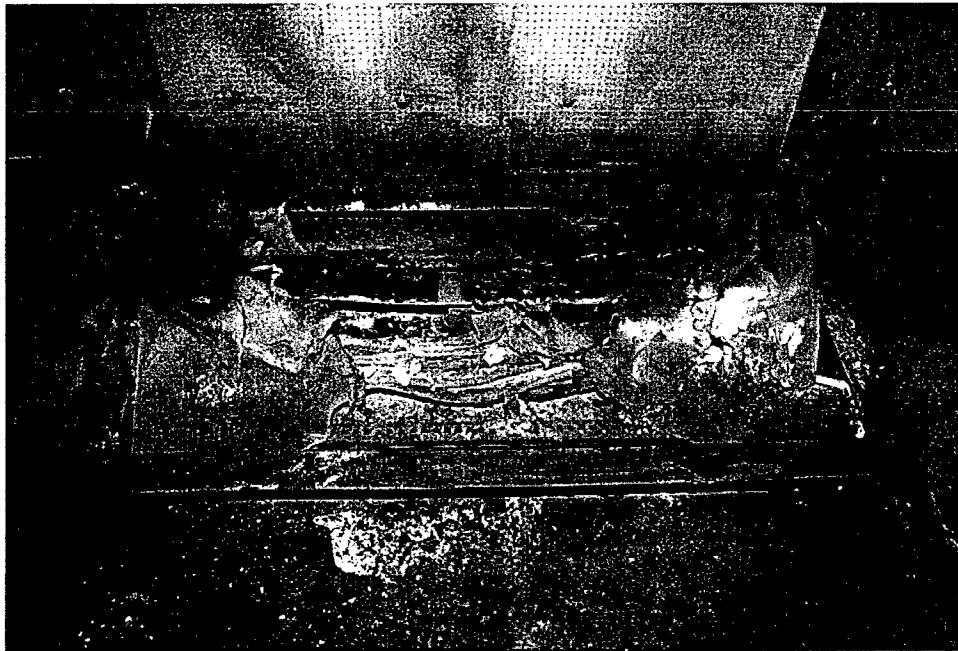
Figure 26. Post-Test Damage to Bundle 1 (Insulation 3 Test)

In addition to the burned out cables, large flakes of charred GRP facing material from the Nomex 1 panel are visible.

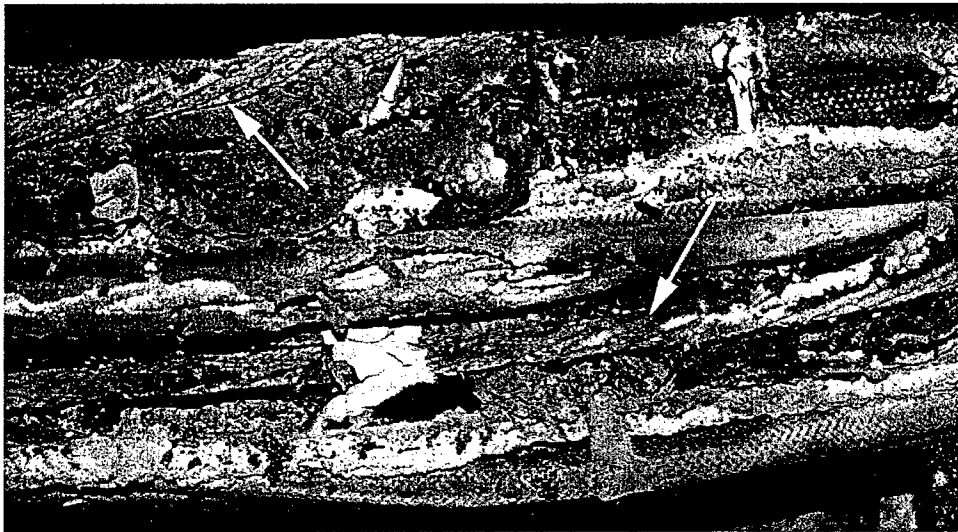
Figure 27. Close-up of Damage to Bundle 1 (Insulation 4 Test)

This close-up view of a portion of Bundle 1 shows that the insulation has been completely burned off in places (arrows), exposing the conductors.

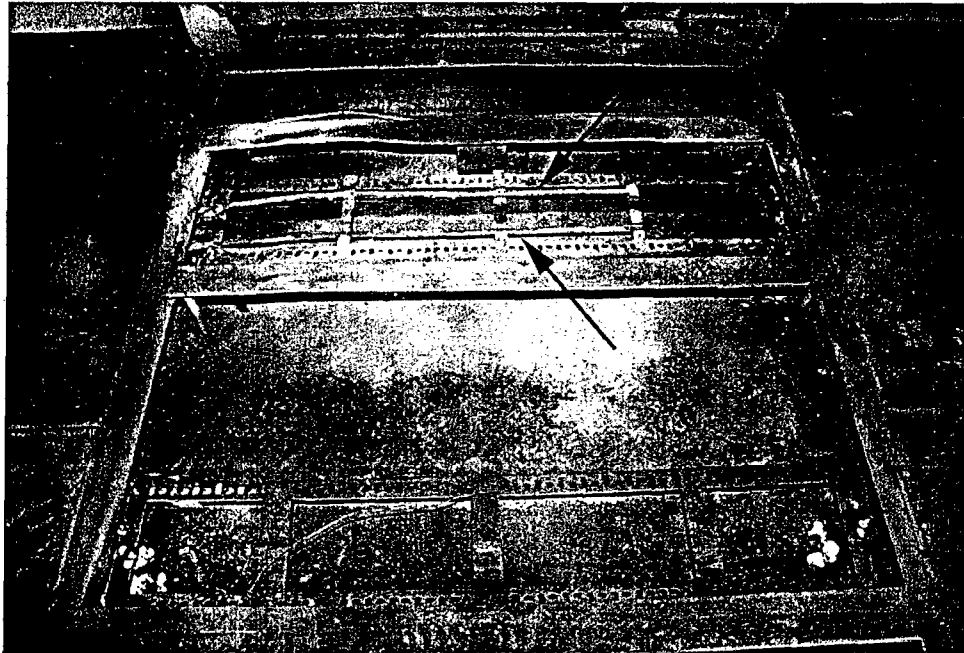
Figure 28. Heater Rod Placement (Spray Baseline Test)

The purpose of the Spray Baseline test was to measure the effects of the ignition sources, especially the spray fire, on the environmental conditions within the test compartment. In this test, two spray nozzles and two heater rods were used, just as in the previous two cases, but there were no combustible materials (cables, deck panels or insulation) in the test compartment. The pre-test arrangement is shown in Figure 28.

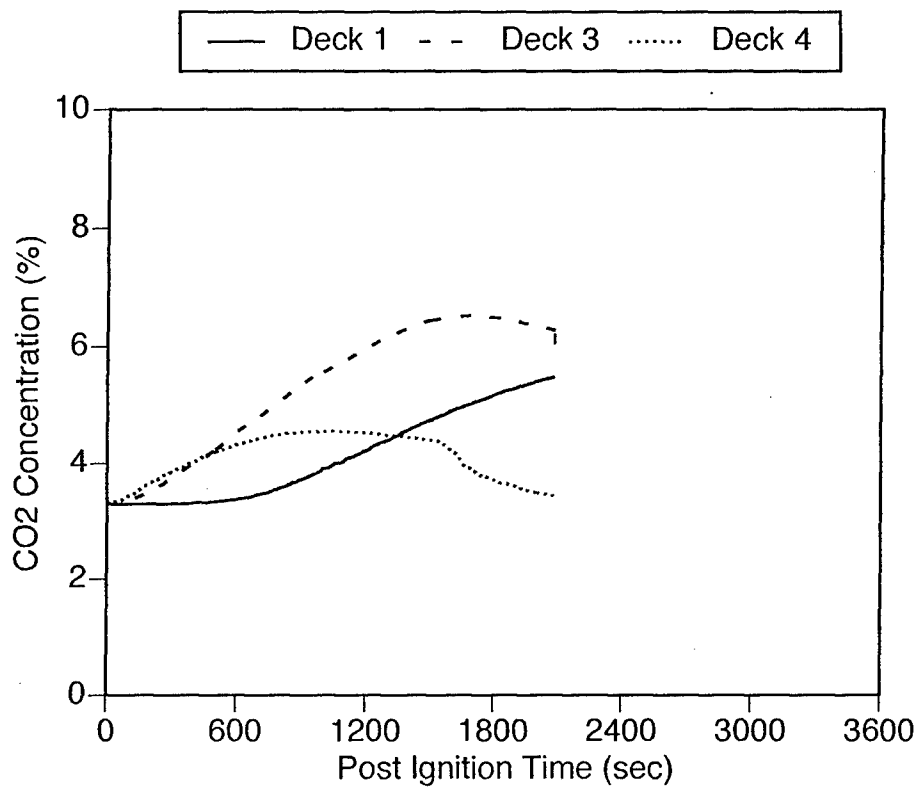
Figure 29. Comparison of CO<sub>2</sub> Concentrations for Group 1 Tests

After alignment of the cable ignition times at time zero, as discussed in the text, the carbon dioxide concentrations for the three Group 1 tests could be directly compared.

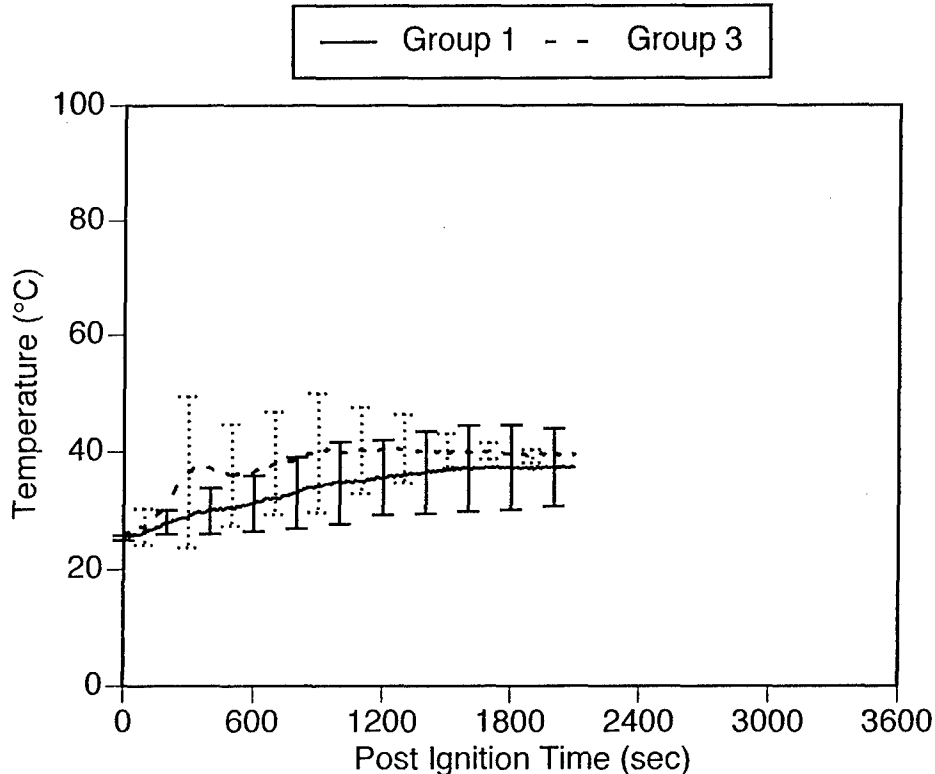
Figure 31. Above Deck Group 1 and Group 3 Air Temperatures

The mean above deck air temperatures from the Group 1 and Group 3 tests are shown. The error bars represent one standard deviation (solid bars correspond to Group 1; dotted bars to Group 3).

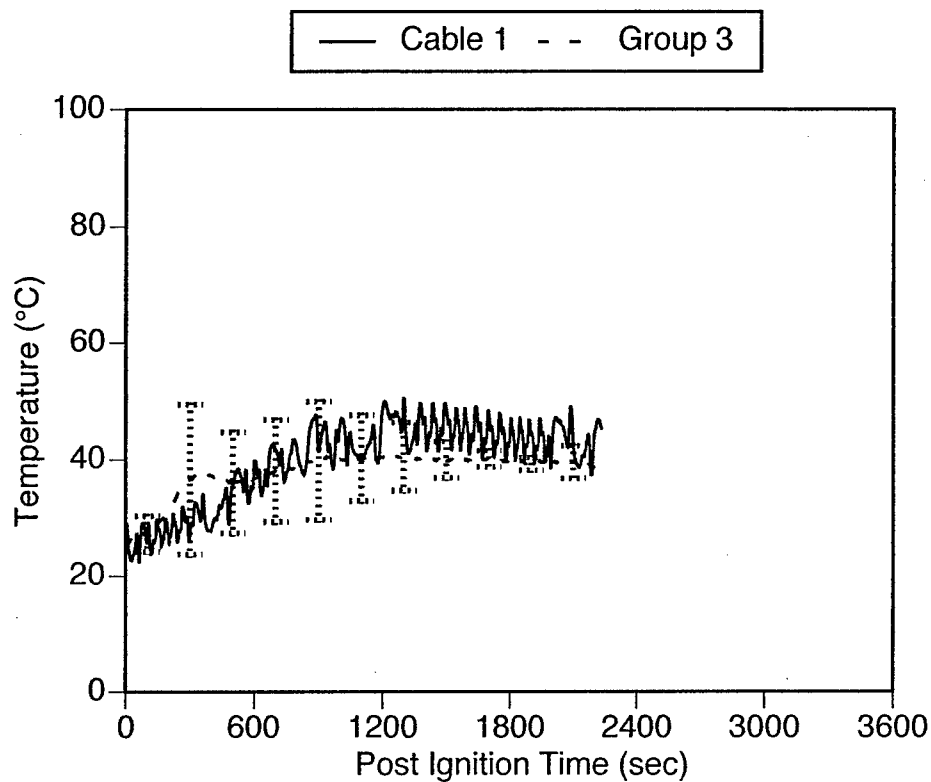
Figure 32. Above Deck Cable 1 and Group 3 Air Temperatures

The above deck air temperatures from the Cable 1 test are compared with those from the Group 3 tests. The dotted error bars represent one standard deviation for the Group 3 results; Cable 1 was a single test and, therefore, no errors could be calculated.

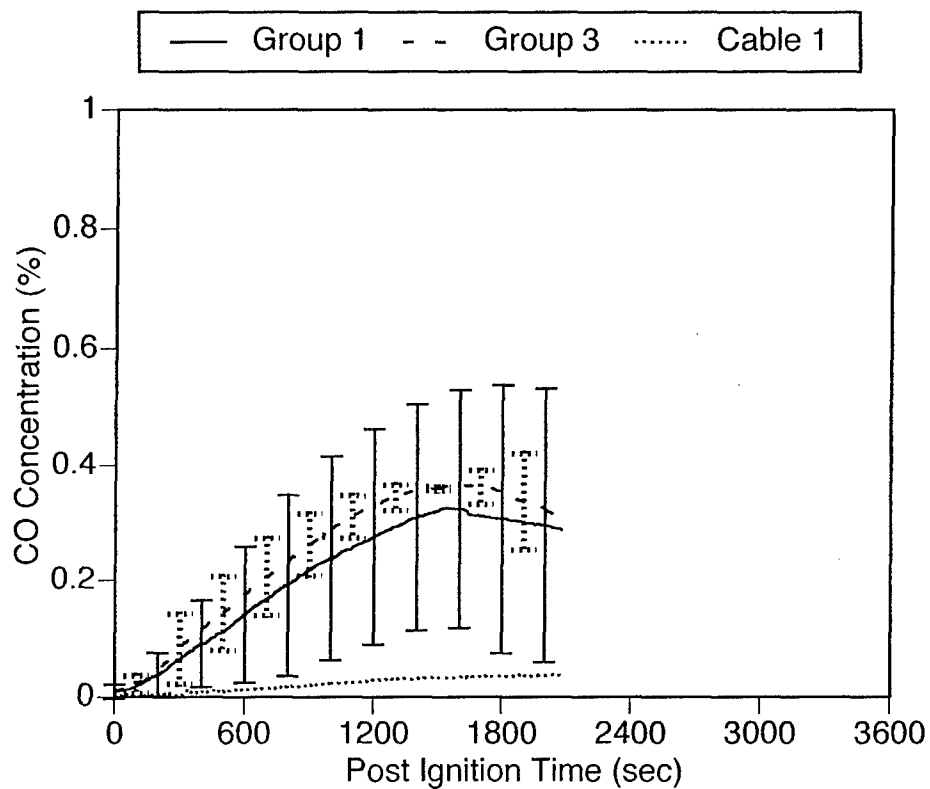
Figure 33. CO Concentrations for Group 1, Group 3 and Cable 1 Tests

Group 1 and Group 3 carbon monoxide concentrations were virtually indistinguishable, but the values from the Cable 1 test were much lower. The error bars represent one standard deviation (solid bars correspond to Group 1; dotted bars to Group 3).

Similar data for gas concentrations and optical transmission are shown in Figures 33 — 36. Again, the Group 1 and Group 3 tests have overlapping error bars and, except for carbon monoxide and transmission, the Cable 1 results are also within the error limits.

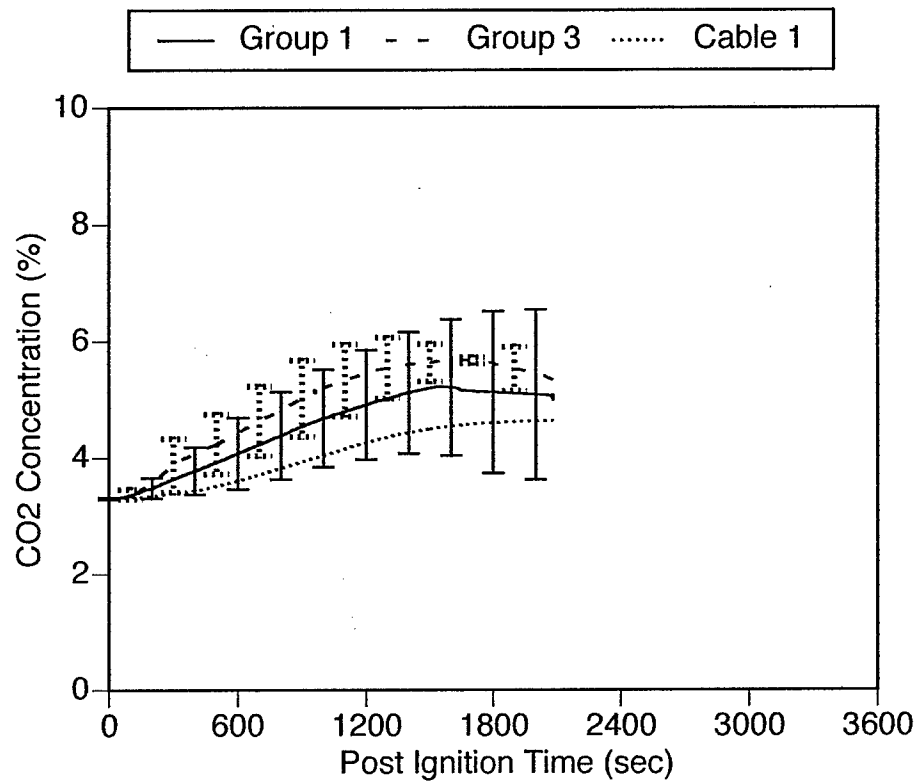
Figure 34. CO<sub>2</sub> Concentrations for Group 1, Group 3 and Cable 1 Tests

Carbon dioxide concentrations were very similar for Cable 1, Group 1 and Group 3. The error bars represent one standard deviation (solid bars correspond to Group 1; dotted bars to Group 3).

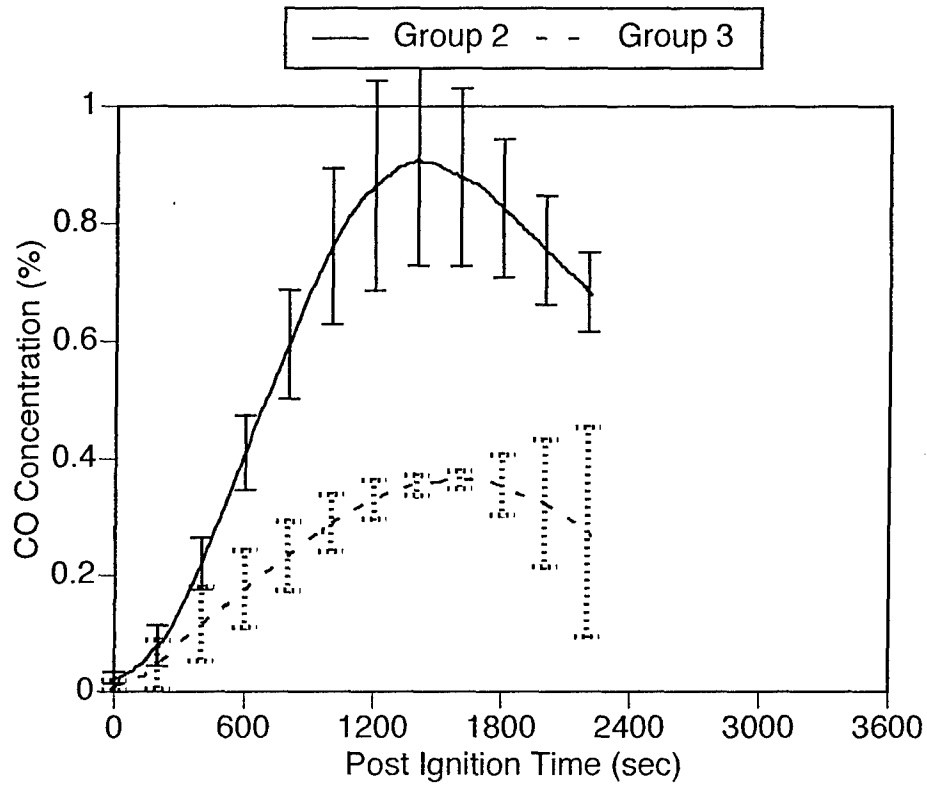
Figure 39. CO Concentrations for Group 2 and 3 Tests

The error bars represent one standard deviation (solid bars correspond to Group 2; dotted bars to Group 3).

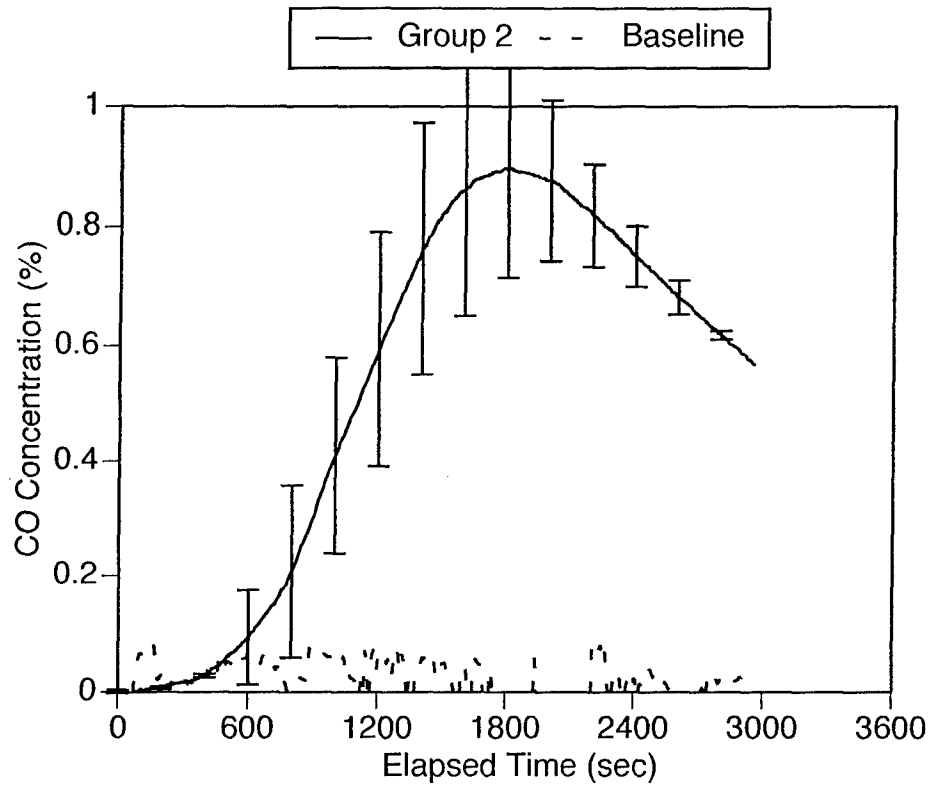
Figure 45. CO Concentrations for Spray Baseline and Group 2 Tests

The error bars represent one standard deviation.
